DirectFET™ Technology

Inspection Application Note

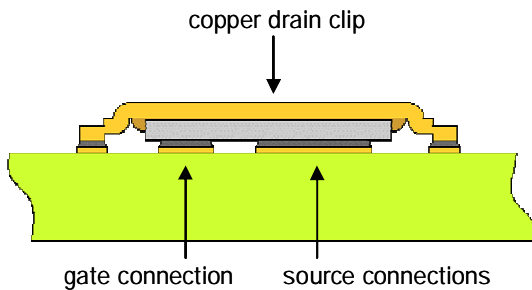
Figure 1 Side view of DirectFET device

International Rectifier's DirectFET technology facilitates dual-sided cooling of surface mounted power MOSFET devices. This doubles power and current densities, which in turn reduces component count and system cost. These benefits result from the presence of solderable contacts on the surface of the silicon die for connecting the gate and source to the printed circuit board (PCB). A copper clip attached to the back of the die provides the drain connection. Devices in the DirectFET range vary but, typically, there are three electrical connections (gate, source and drain) but seven or more mechanical joints (one gate pad, one or more source pads, and four drain pads – each of the two drain rails is divided into two pads). Figures 1 and 2 show this construction.

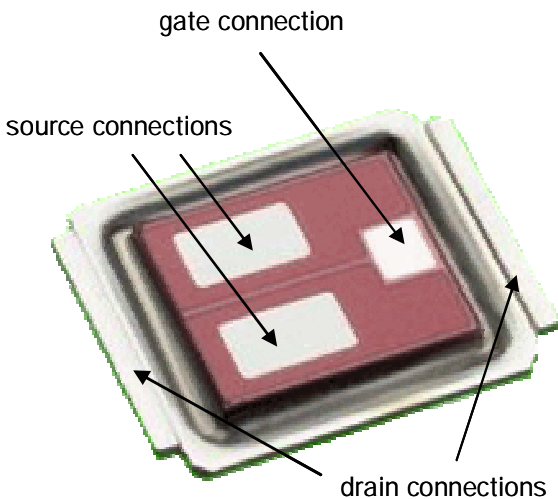
Figure 2 Bottom view of DirectFET device

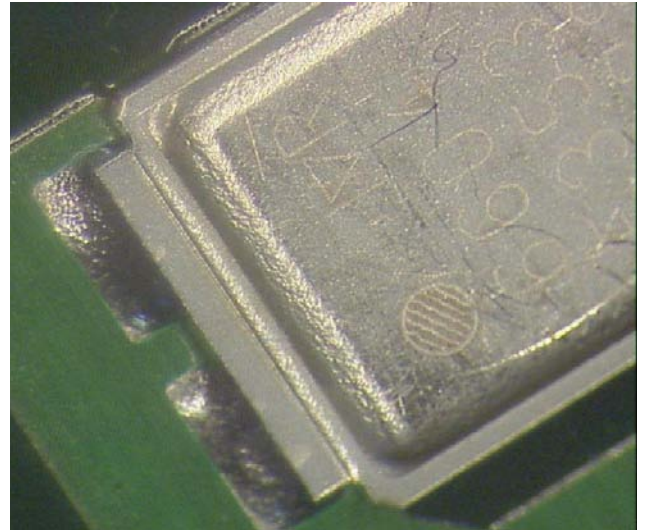
The drain connections on a DirectFET device are external, conventionally filleted solder joints (Figure 3). This means that they can be inspected visually, as with a conventional SMD, in accordance with industry standards (for example, IPC-A-610).

Figure 3 External solder fillets on the drain

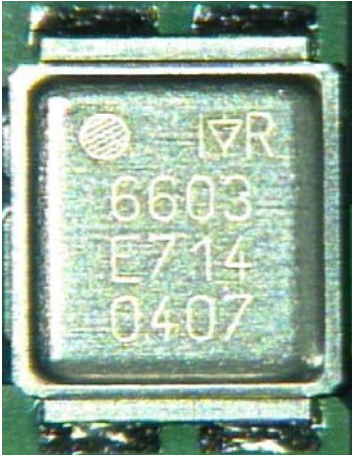
Figure 4 Self-centered with good solder fillets

Figures 4 to 6 show well-mounted DirectFET devices.

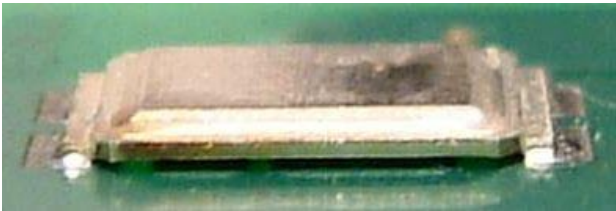
Figure 5 Device mounted parallel to PCB

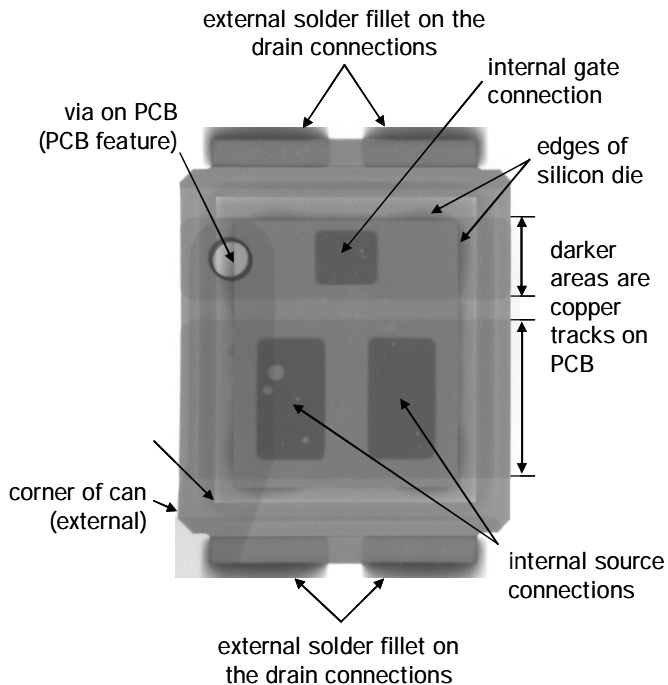
Figure 6 Features revealed by an X-ray

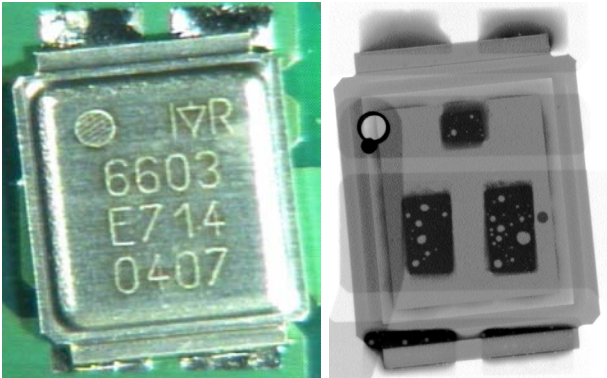
This describes a device that is mounted crookedly on the pads, as shown in Figure 7. The device is clearly twisted but external solder fillets are still visible on all four drain contacts. The X-ray shows good solder joints on the gate and source contacts.

Figure 7 Twisted device

Reject twisted devices if one of the following is true:

- There is less than 75% coverage on gate or source contacts
- There is less than 50% coverage on drain contacts

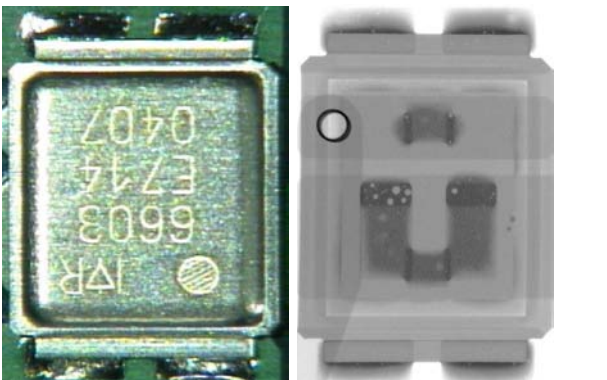
This describes a device that is mounted the wrong way around, as shown in Figure 8. Although the external solder fillets on the drain contacts are good, the X-ray reveals the problems with the gate and source contacts. You can see in the photograph that the device markings are upside down.

Figure 8 Rotated device

Reject all rotated devices.

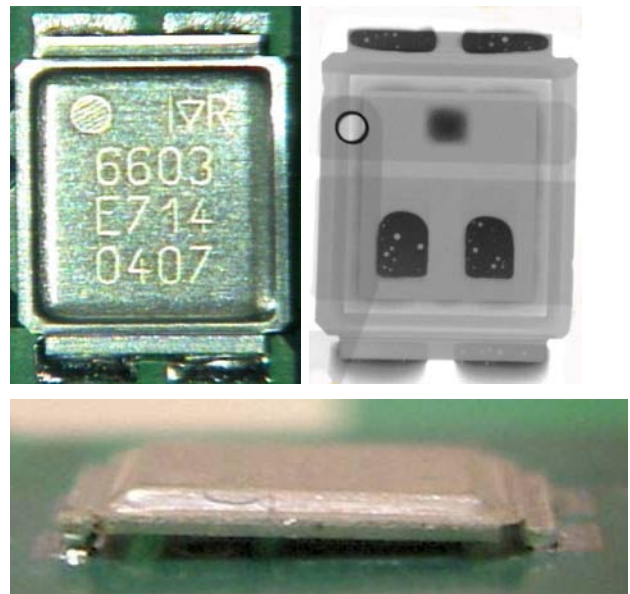
This describes a device that is not parallel to the PCB. Figure 9 shows an example. Although the device is self-centered, visual inspection from above reveals more solder on the bottom drain contacts in the photograph than on the top ones. This indicates a problem with the solder process: solder has been sucked underneath the device. Visual inspection from the side reveals that the device is tilted by more than 3°. This again indicates a problem with solder under the device. The X-ray confirms the problem; it also reveals that the gate contact is not made and the tops of the source contacts are indistinct, indicating that the joints are tapered.

Figure 9 Tilted device

Reject tilted devices if one of the following is true:

- There is less than 75% coverage on gate or source contacts
- There is less than 50% coverage on drain contacts
- The angle of tilt exceeds 3°

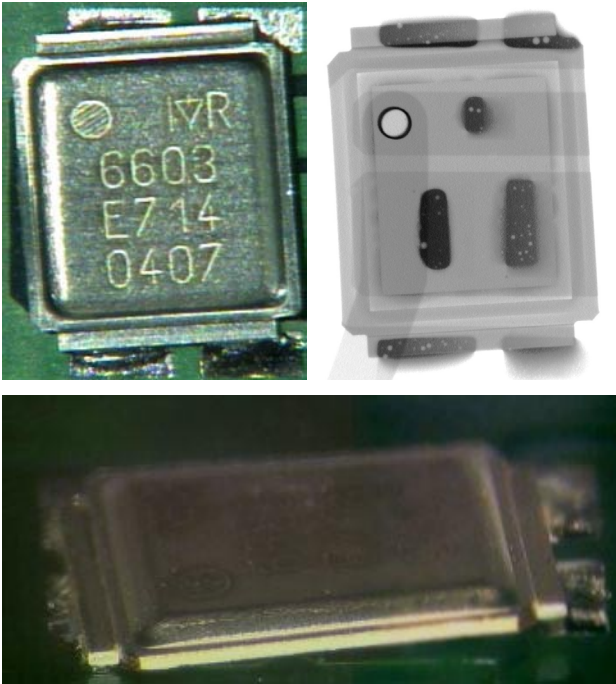
This describes a device that is both crooked on the pads and not parallel to the PCB, as shown in Figure 10. Visual inspection from above reveals the twist and from the side reveals the tilt. The X-ray shows the combined effects, with the contact area reduced by the twist and the pad definition impaired by the tilt. The contacts on the right side of the device are poorly made.

Figure 10 Twisted and tilted device

Reject twisted and tilted devices if:

- There is less than 75% coverage on gate or source contacts
- There is less than 50% coverage on drain contacts
- The angle of tilt exceeds 3°

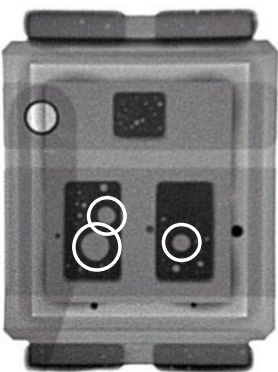
This describes joints in which some areas have no solder, as shown in Figure 11.

Figure 11 Examples of solder voids

Many industry standards (for example, IPC-A-610) accept voiding levels of up to 25% of the joint area. International Rectifier has carried out reliability tests on devices with 30% solder voiding that showed no deterioration in parametric or long-term reliability testing results.

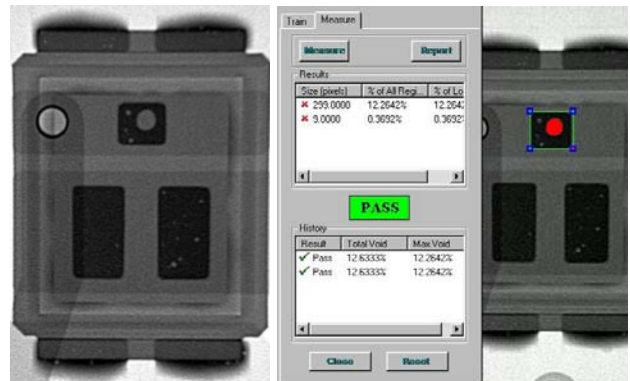
software. Estimating the percentage of solder voiding intuitively from an image invariably leads to inaccurate, usually exaggerated, results. Typically, people tend to judge the level of voiding to be about double the true amount. Figures 12 and 13 show two examples where viewers estimated about 20% of the contact area to be affected but imaging software revealed the true value to be only 12-13%. This demonstrates the importance of good image analysis software.

Figure 12 Voids on the gate contact

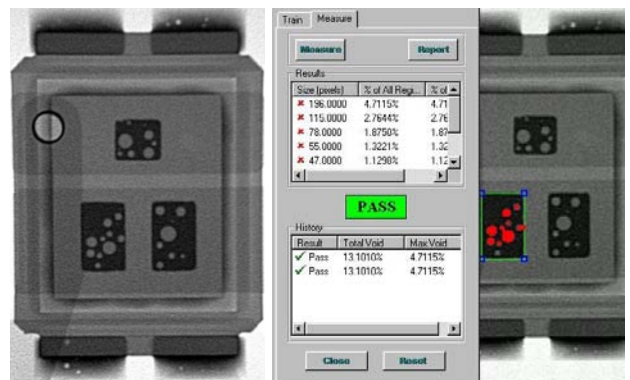
Figure 13 Voids on the left source contact

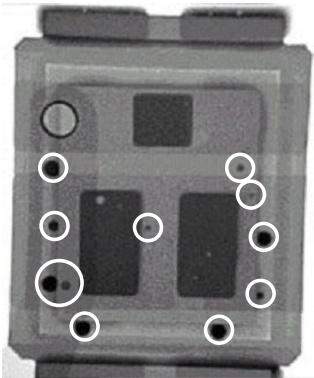
This describes spheres of excess solder left after reflow (Figure 14). In its most extreme form, it may result in short circuits.

Figure 14 Examples of solder balls

As with any SMD, the aim in assembling DirectFET devices is to achieve good solder coverage of the joint area without solder balling. However, it is not always possible to achieve the ideal amount of solder, and solder balls sometimes form. In addition to solder quantity, an incorrect reflow profile (ramp rate too high) can cause solder balling; this happens because the solvent and/or flux boils, ejecting solder particles from the body of solder.

Although solder balling is not desirable, a few solder balls need not necessarily be an issue. There is no evidence to suggest that solder balling impairs the function, performance or reliability of DirectFET devices. This is because, once the device has been

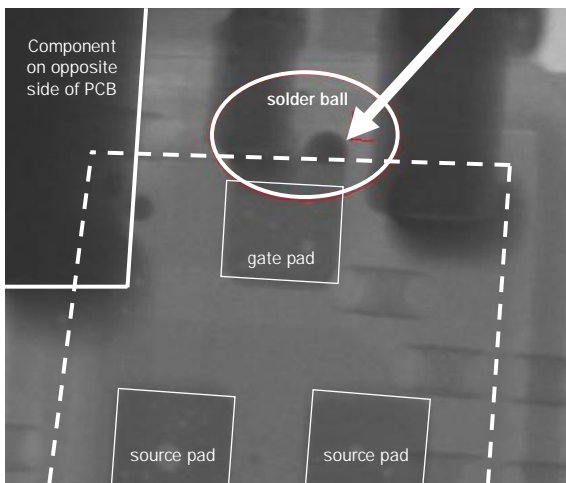
Only a solder ball next to the gate pad, as shown in Figure 15, is likely to present problems. Although the ball will not itself cause an electrical short, a smear of flux, solder particles or contaminant could lead to an electrical short or leakage in certain circumstances. This is very rare but can be exacerbated if the device shifts during reflow.

Figure 15 Example of a problematic solder ball

1. **Position** Solder balls are a concern only when they occur next to the gate pad, between it and the closest drain pad.
2. **Shorting** Use electrical tests to check for shorts. If there are no shorts when the device is mounted, there is no evidence to suggest that solder balls can cause shorting later.

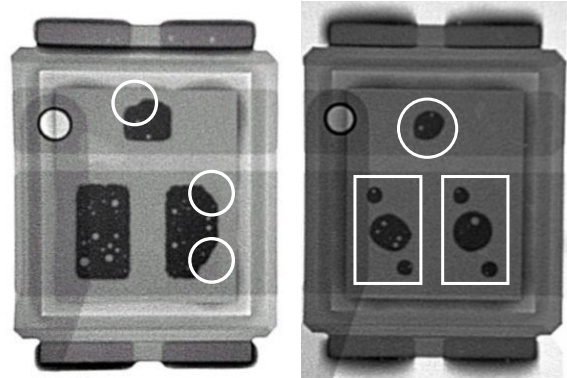
This describes joints in which the full area of the pad is not in contact. In its most extreme form, it may result in open circuits. Poorly formed solder joints appear on X-ray images as irregular patterns and shapes, as shown in Figure 16.

Figure 16 Examples of poorly formed joints

Poorly formed joints are acceptable unless the area affected exceeds 25% of the joint. There is no need to rework or reject devices until this level is exceeded. However, if poor joints often occur, use process engineering or optimization and yield improvement exercises to rectify the situation.

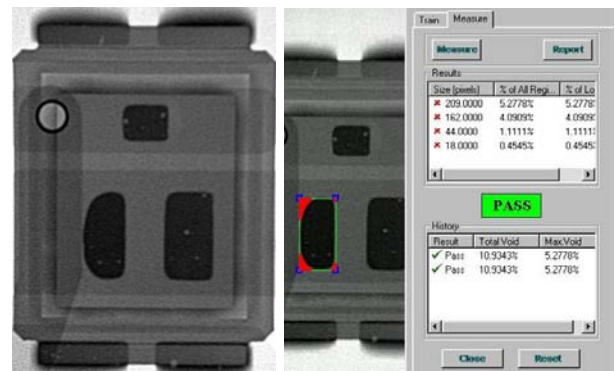
As with voiding, use imaging or pixel-counting software to evaluate the extent of the affected area. Figures 17 and 18 show examples.

Figure 17 Poorly formed source joint – 11% missing

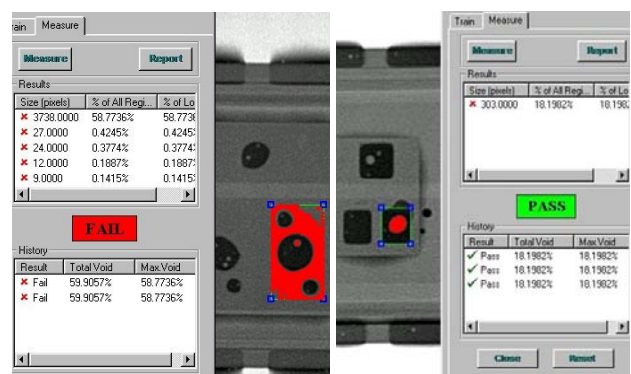
Figure 18 Fail (60% missing) and pass (18%) results

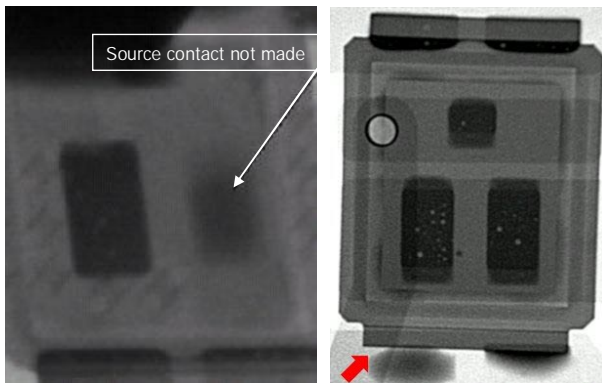
This describes failed joints where there is no electrical connection. Open circuits appear on X-ray images as pads that are faint and/or poorly defined. Figure 19 shows two examples of open circuits:

1. The image on the left shows an open connection on a source pad. There is no electrical connection so this device would have to be rejected or reworked.
2. The image on the left shows a drain rail where one of the two pads is open. This should be rejected because it has a maximum of 50% coverage, even if the other joint is perfect.

Figure 19 Examples of open circuits

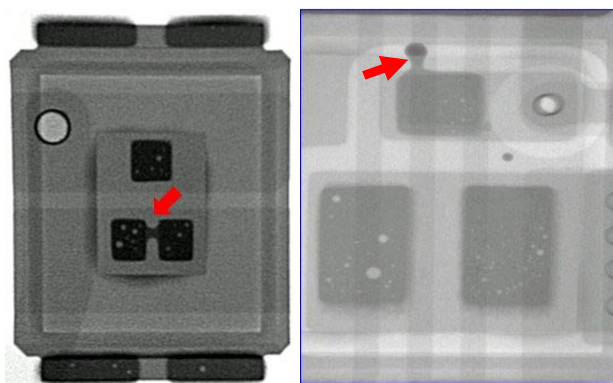
This describes accidental electrical connections between contacts that should be isolated. Like solderballing, it results from excess solder. Figure 20 shows two examples of short circuits:

1. The image on the left shows a solder bridge between the source pads. Although this is undesirable, it is acceptable because the pads are electrically common.
2. The image on the right shows a solder bridge between the gate pad and a track on the PCB. This must be rejected or reworked. It might be detected in electrical testing if not by X-ray.

Figure 20 Examples of short circuits

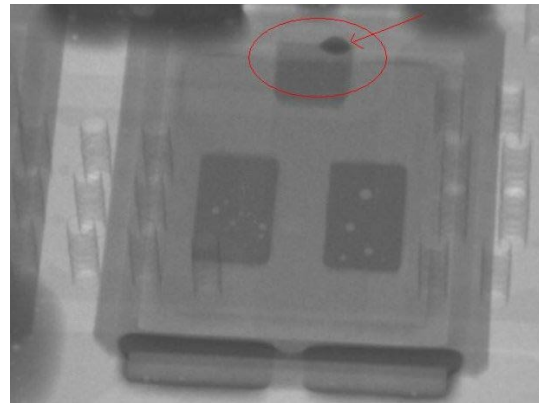
Figure 21 shows the gate pad on the PCB extending beyond the edge of the die. Although the border of passivated silicon between the edge of the gate contact and the edge of the die on the device should prevent problems from arising, PCB pads should be defined accurately.

Figure 21 Over-sized gate pad on PCB

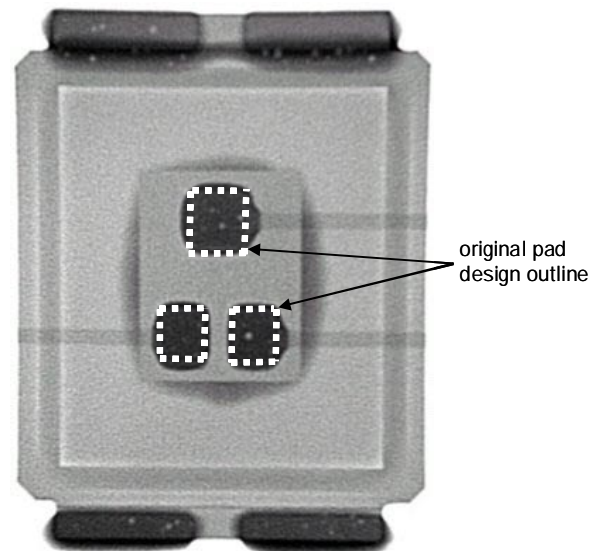
Figure 22 shows poor edge definition on solder joints. The cause is the lack of a solder mask to define the gate and source pads; they are defined only by the edge of the copper track.

Figure 22 Absence of a solder mask to define pads
